Lacamas Shores Homeowners Association
Northwest Barlow Street & Northwest Lacamas Drive
Camas, Washington 98607
Account 712 - Version 5

Fiscal Year: January 1, 2018 to December 31, 2018

RESERVE STUDY & MAINTENANCE PLAN

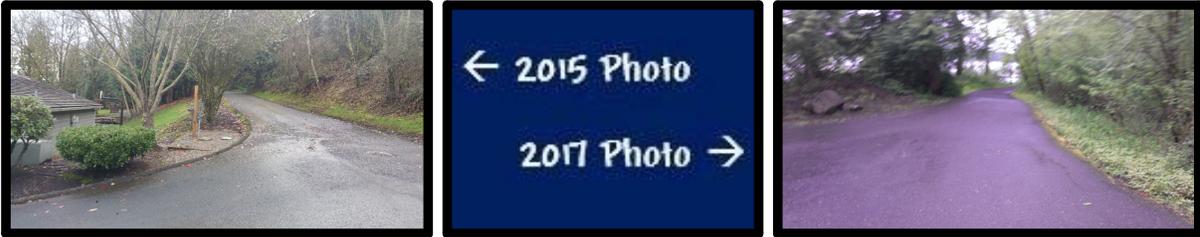
Asphalt Overlay		24,615 Square Feet	@ \$2.29
Asset ID	1003	Asset Cost	\$56,343.73
	Capital	Percent Replacement	100%
	Streets/Asphalt	Future Cost	\$77,268.34
Placed in Service	July 1988	Assigned Reserves	\$21,914.33
Useful Life	50		
Adjustment	-2	Monthly Assessment	\$208.88
Replacement Year	2036	Interest Contribution	<u>\$19.48</u>
Remaining Life	18	Reserve Allocation	\$228.36

Revised 10/29/2017 Notes for 2018 Reserve Study Update:

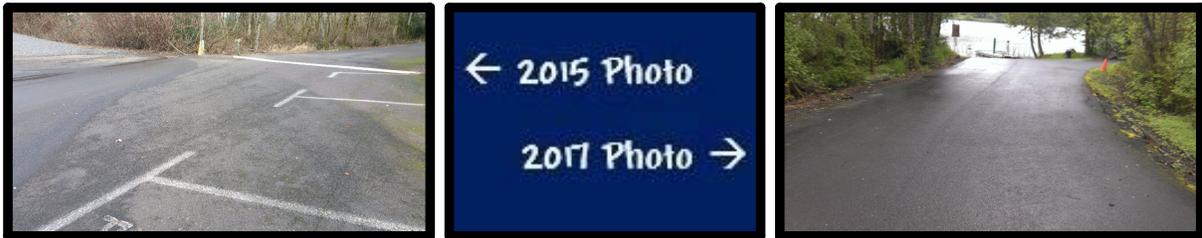
24,615 Square Feet	@ \$3.56
Asset ID	1002	Asset Cost	\$4,382.70
	Capital	Percent Replacement	5%
	Streets/Asphalt	Future Cost	\$4,460.27
Placed in Service	April 2017	Assigned Reserves	\$2,191.35
Useful Life	5		
Adjustment	-3	Monthly Assessment	\$178.53
Replacement Year	2019	Interest Contribution	\$2.80
Remaining Life	1	Reserve Allocation	\$181.34

Revised 11/03/2017 Notes for 2018 Reserve Study Update:

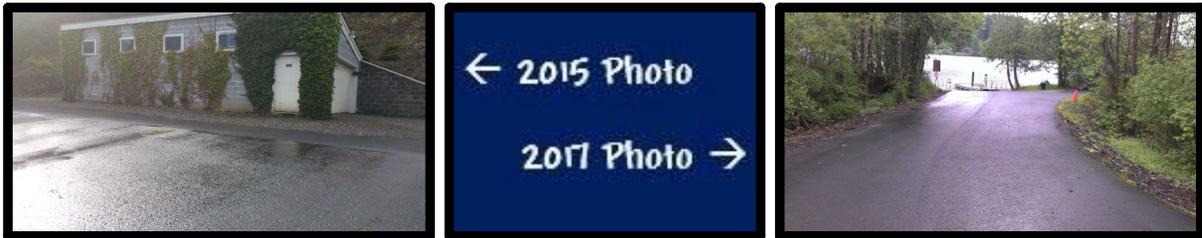
Asphalt Seal Coat		24,615 Square Feet	@ \$0.28
Asset ID	1001	Asset Cost	\$6,990.66
	Non Capital	Percent Replacement	100%
	Streets/Asphalt	Future Cost	\$7,114.39
Placed in Service	January 2008	Assigned Reserves	\$6,355.15
Useful Life	5		
Adjustment	6	Monthly Assessment	\$57.20
Replacement Year	2019	Interest Contribution	<u>\$5.63</u>
Remaining Life	1	Reserve Allocation	\$62.84

Revised 10/29/2017 Notes for 2018 Reserve Study Update:

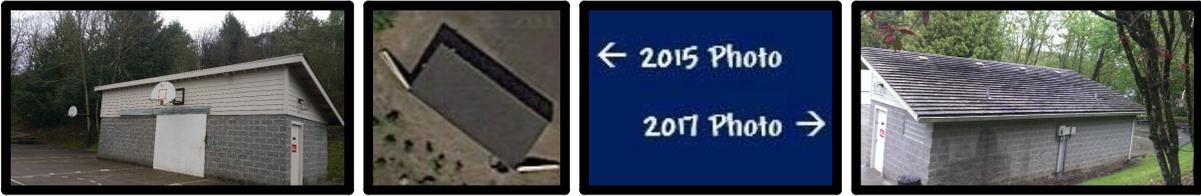
660 Square Feet	@ \$3.47
Asset ID	1042	Asset Cost	\$229.02
	Capital	Percent Replacement	10%
	Roofing	Future Cost	\$245.67
Placed in Service	July 2017	Assigned Reserves	\$45.80
Useful Life	5		
Replacement Year	2022	Monthly Assessment	\$3.77
Remaining Life	4	Interest Contribution	<u>\$0.06</u>
		Reserve Allocation	\$3.83

Revised 10/29/2017 Notes for 2018 Reserve Study Update:

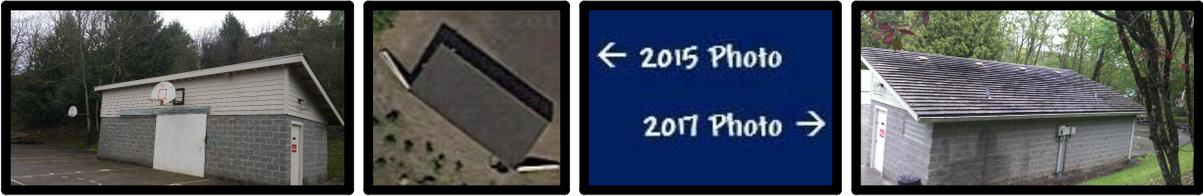
660 Square Feet	@ \$2.48
Asset ID	1008	Asset Cost	\$1,640.10
	Capital	Percent Replacement	100%
	Roofing	Future Cost	\$2,289.00
Placed in Service	October 2017	Assigned Reserves	<i>none</i>
Useful Life	20		
Replacement Year	2037	Monthly Assessment	\$8.40
Remaining Life	19	Interest Contribution	<u>\$0.05</u>
		Reserve Allocation	\$8.44

Revised 10/29/2017 Notes for 2018 Reserve Study Update:

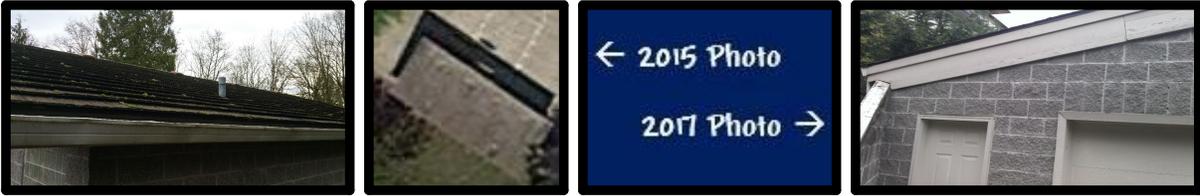
990 Square Feet	@ \$3.53
Asset ID	1041	Asset Cost	\$349.57
	Capital	Percent Replacement	10%
	Roofing	Future Cost	\$374.98
Placed in Service	October 2017	Assigned Reserves	\$69.91
Useful Life	5		
Replacement Year	2022	Monthly Assessment	\$5.76
Remaining Life	4	Interest Contribution	<u>\$0.09</u>
		Reserve Allocation	\$5.85

Revised 10/29/2017 Notes for 2018 Reserve Study Update:

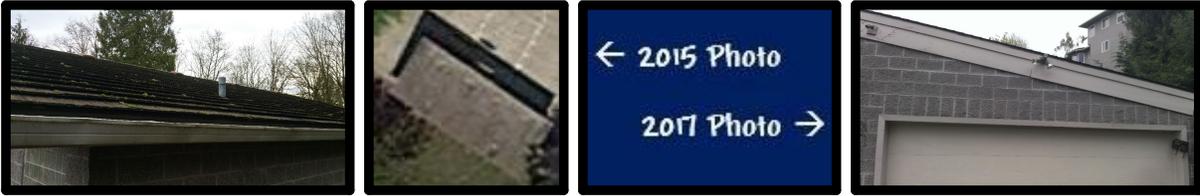
990 Square Feet	@ \$3.53
Asset ID	1009	Asset Cost	\$3,495.69
	Capital	Percent Replacement	100%
	Roofing	Future Cost	\$4,878.75
Placed in Service	October 2017	Assigned Reserves	<i>none</i>
Useful Life	20		
Replacement Year	2037	Monthly Assessment	\$17.90
Remaining Life	19	Interest Contribution	<u>\$0.10</u>
		Reserve Allocation	\$17.99

Revised 10/29/2017 Notes for 2018 Reserve Study Update:

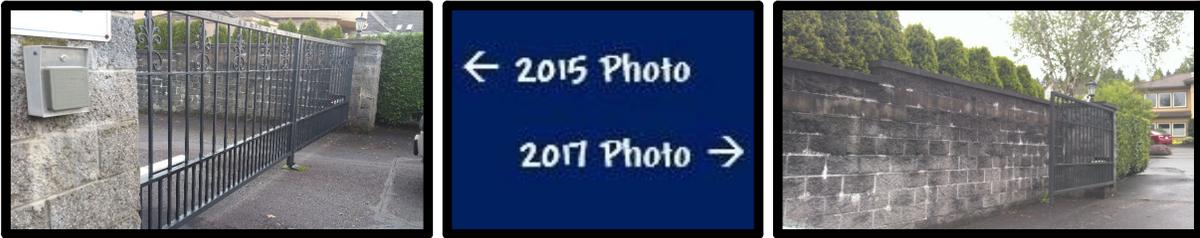
1 Lump Sum	@ \$5,902.66
Asset ID	1039	Asset Cost	\$5,902.66
	Capital	Percent Replacement	100%
	Fencing/Security	Future Cost	\$7,414.89
Placed in Service	July 2000	Assigned Reserves	\$3,427.35
Useful Life	30		
Adjustment	1	Monthly Assessment	\$20.34
Replacement Year	2031	Interest Contribution	<u>\$2.98</u>
Remaining Life	13	Reserve Allocation	\$23.32

Notes for 2018 Reserve Study Update:

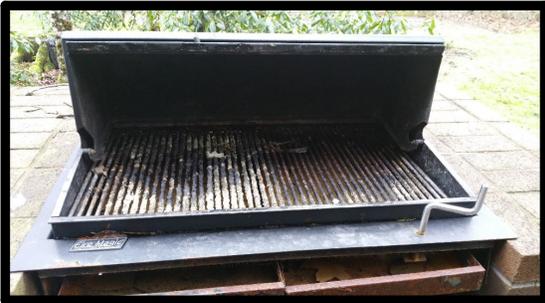
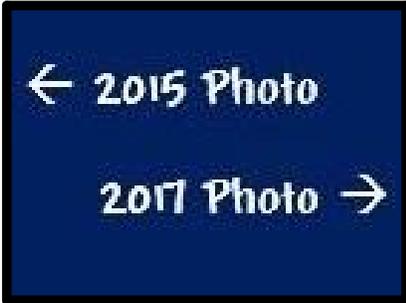
Barbeque - Replenish / Rebuild

BBQ was renovated at a cost of \$1284 in 2017. Total of \$1200 per the Board.

Included all three BBQ units/rebuild per the Board of Directors. Work/rebuild/replacement expected during 2017 subsequent to the publication of this reserve study, but prior to the commencement of the 2018 fiscal year. Cost provided by the Board of Directors.

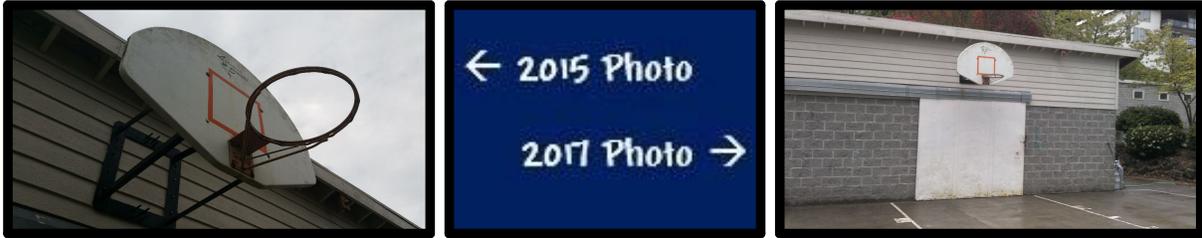
Basketball Goal - Backboard/Hoop/Mounting Hardware

This line item is for the tear-down, disposal, replacement of the basketball goal, hoop, and associated mounting hardware. Costs are based upon similar units found at Big 5 Sports and installation. Hoop and goal appear to be in fair condition.

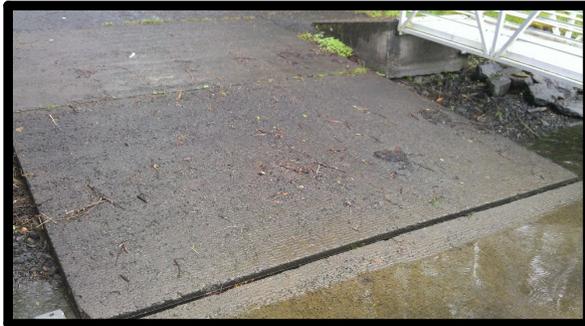
Boat Ramp

Some work was completed on the boat launch in the amount of \$3152. Revised cost of \$6000 per the Board.

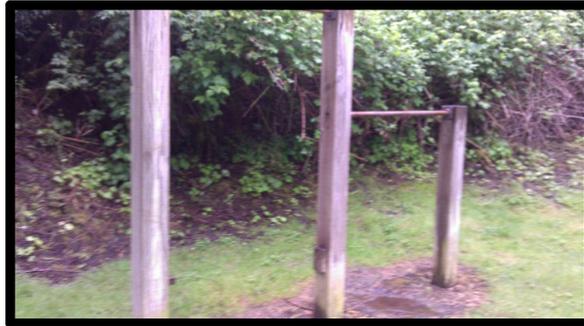
Exercise Equipment: Rebuild / Major Repairs

According to the Board of Directors, minor repairs performed in 2017 at a cost of \$650.

This line item is for the major rebuild and replacement of portions of the various playground structures, fitness equipment including any cedar chips. Scope of work to be determined by the Board.

Suitable replacement parts may become difficult or impossible to find as overall system ages.

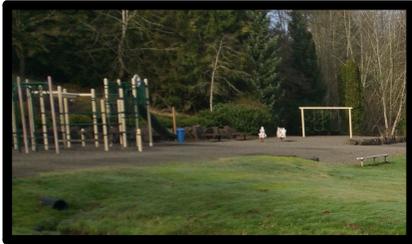
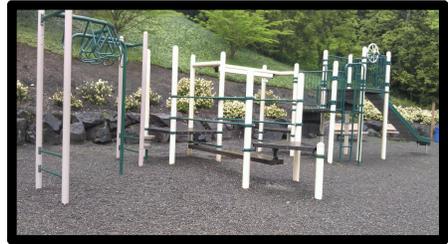
Playground Equipment: Rebuild / Major Repairs

Component cost has been increased in order to compensate for the inflation since the most recent (2015) reserve study update report. Timing moved to 2022 per the Board of Directors. Some minor repairs occurred to the existing playground equipment in 2017. Exercise equipment has a new line item per the Board of Directors.

This line item is for the major rebuild and replacement of portions of the various playground structures, fitness equipment including any cedar chips. Scope of work to be determined by the Board.

Suitable replacement parts may become difficult or impossible to find as overall system ages.

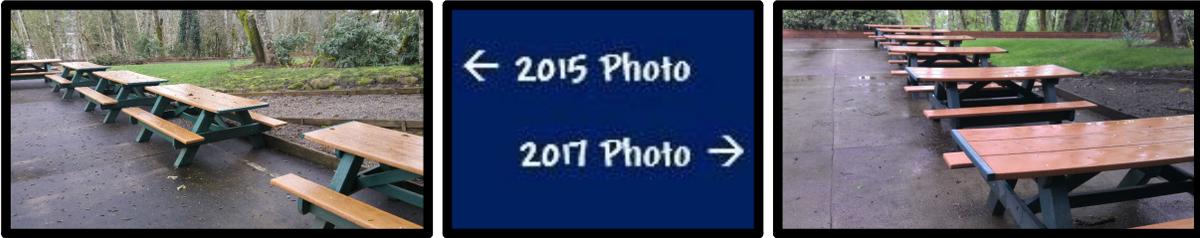
Site Furniture - Benches/Tables & Miscellaneous

This line item is for a provision for the replacement of the outdoor furniture such as the picnic benches in the common area from time-to-time. Total is based on a lump sum, therefore "Placed in Service" date is an approximation to properly commence the funding for this line item based on an overall average visual condition of components contained. Furniture appears to be in good overall condition. Cost based upon similar equipment available at Home Depot.

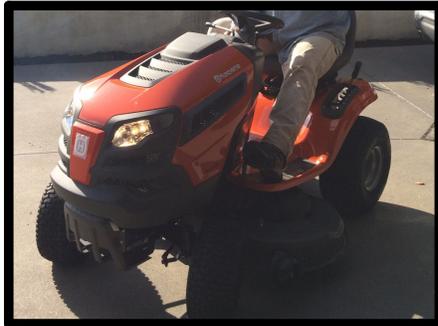
Mower: Riding - Replace

Cost per information provided by the Board of Directors. Lifespan assumes that the mower is maintained in accordance with manufacturer's specifications. Board of Directors should affirm the replacement timing with their vendor. Item is in "new" condition.

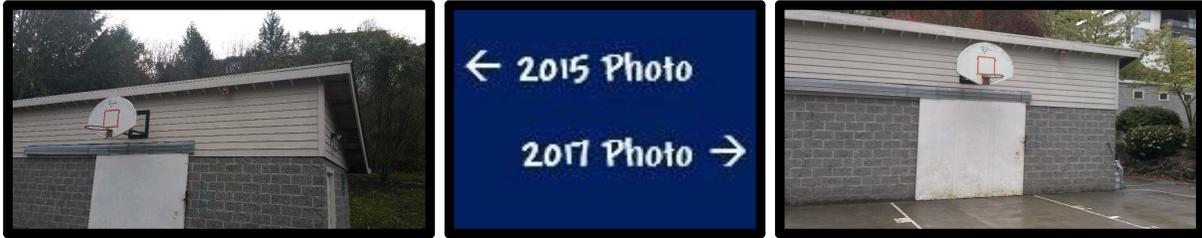
155 Linear Feet	@ \$4.83
Asset ID	1011	Asset Cost	\$749.27
	Capital	Percent Replacement	100%
	Gutters and Downspouts	Future Cost	\$892.97
Placed in Service	January 2008	Assigned Reserves	\$374.63
Useful Life	20		
Replacement Year	2028	Monthly Assessment	\$3.64
Remaining Life	10	Interest Contribution	<u>\$0.33</u>
		Reserve Allocation	\$3.97

Notes for 2018 Reserve Study Update:

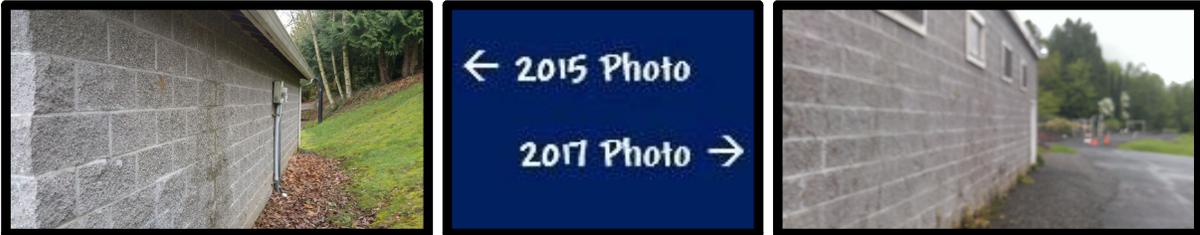
135 Linear Feet	@ \$4.83
Asset ID	1010	Asset Cost	\$652.59
	Capital	Percent Replacement	100%
	Gutters and Downspouts	Future Cost	\$777.75
Placed in Service	January 2008	Assigned Reserves	\$326.29
Useful Life	20		
Replacement Year	2028	Monthly Assessment	\$3.17
Remaining Life	10	Interest Contribution	<u>\$0.29</u>
		Reserve Allocation	\$3.46

Notes for 2018 Reserve Study Update:

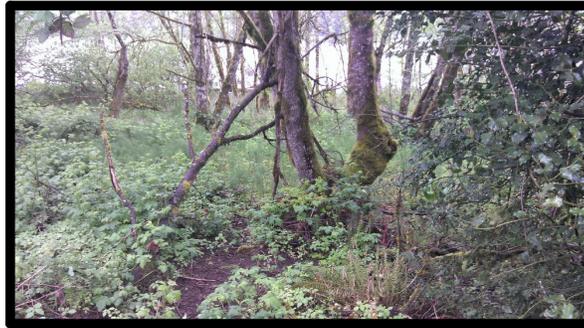
Storm Drainage System

Renamed from "Wetland Renovation" to "Storm Drainage System". Moved to 2018. Cost changed to \$35,000. Category changed to "Environmental Remediation". The preceding is per the Board's instruction.

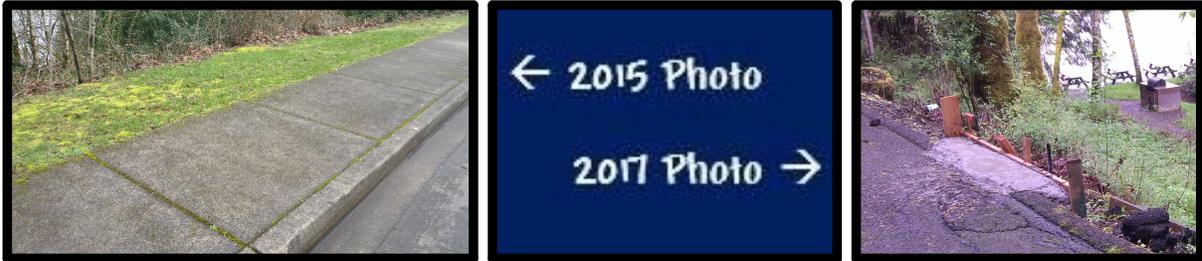
6,970 Square Feet	@ \$12.43
Asset ID	1017	Asset Cost	\$4,330.46
	Capital	Percent Replacement	5%
	Concrete	Future Cost	\$4,727.52
Placed in Service	January 2017	Assigned Reserves	\$721.74
Useful Life	5		
Adjustment	1	Monthly Assessment	\$60.04
Replacement Year	2023	Interest Contribution	<u>\$0.93</u>
Remaining Life	5	Reserve Allocation	\$60.97

Notes for 2018 Reserve Study Update:

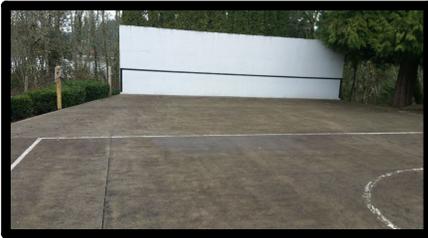
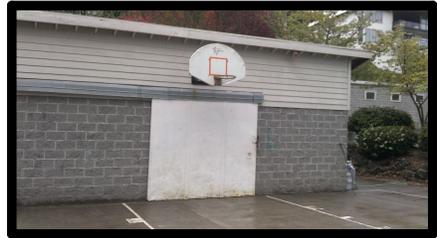
6,970 Square Feet	@ \$12.43
Asset ID	1013	Asset Cost	\$8,660.92
	Capital	Percent Replacement	10%
	Concrete	Future Cost	\$14,405.81
Placed in Service	August 2017	Assigned Reserves	<i>none</i>
Useful Life	30		
Replacement Year	2047	Monthly Assessment	\$32.82
Remaining Life	29	Interest Contribution	<u>\$0.18</u>
		Reserve Allocation	\$33.00

Revised 10/29/2017 Notes for 2018 Reserve Study Update:

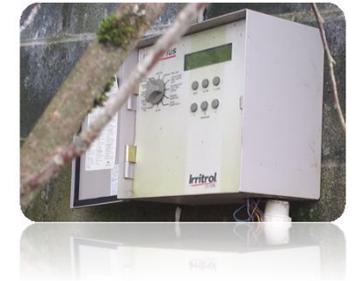
When an electrical impulse is transmitted to the solenoid, an electromagnetic field causes a small metal plunger in the solenoid to move upward. When the plunger moves upward, a small hole in the valve is uncovered which allows the water in the chamber above the closing mechanism to flow through the port and out of the valve, relieving water pressure needed to hold the valve closed. The pressure of the incoming flow of water is greater than the pressure in the chamber above the piston, and the force of the water pushing up underneath the piston opens the valve. When the solenoid is de-energized, the plunger moves down, closing the small port. Water flowing through a small hole in the closing mechanism refills the chamber above the piston and builds up pressure. The increased pressure forces the piston downward, thus closing the valve. All valves have a range of pressure and water flow that must be maintained in order to work properly.
