Reserve Study Update.com, LLC

Lacamas Shores Homeowners Association
Northwest Barlow Street & Northwest Lacamas Drive
Camas, Washington 98607
Account 712 - Draft 2.01

Fiscal Year: January 1, 2025 Expires December 31, 2025

OFF-SITE RESERVE STUDY & MAINTENANCE PLAN

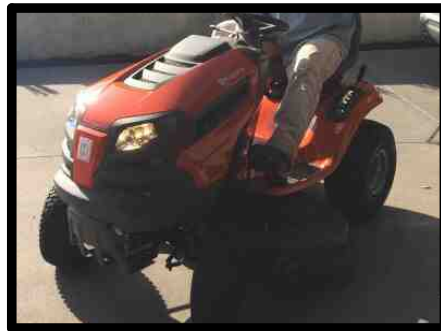
Mower: Riding - Replace [Removed]

Per the Board of Directors, this equipment has been decommissioned. All work on the grounds is performed by independent contractors and no longer employed by Lacamas Shores HOA. No funds have been set aside here. This line item is included for informational purposes only and to show continuity.

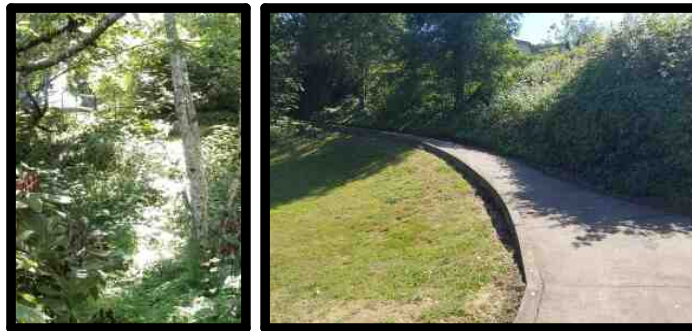
Steps & Pathway [Unfunded]

This line item "Step Replacement & Restabilization" has been removed (and unfunded) from this reserve study as the wooden railroad ties have been since replaced with a concrete pathway. This line item is a placeholder and serves notification to the reader that the line item has been removed from this reserve study.

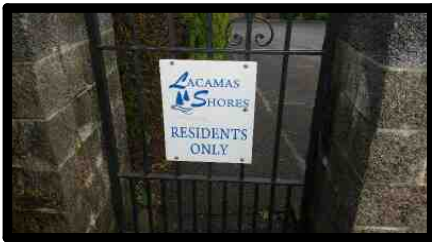
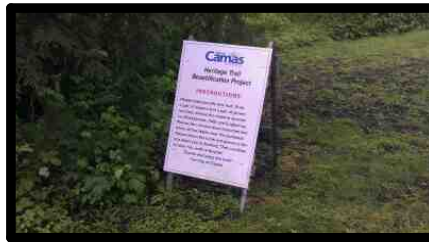
Street Signs [Removed]

This line item is a contingency for the ongoing replacement of the various signs including street signs in the community. DOT signs should be manufactured with a reflective coating to insure visibility.

ReserveStudyUpdate.com, LLC strongly recommends that the Board obtain at least two or three estimates and/or competitive bids to affirm this estimate. As with any component listed in any of our reserve studies, should the Board and/or management find that these cost projection(s) need to be revised, ReserveStudyUpdate.com, LLC is more than happy to make these changes to the electronic file (PDF) and provide the updated report completely free of charge prior to or during the fiscal year that the study is prepared for. This measure will aid in maintaining proper reserve funding equilibrium and aid in proper contribution to reserves.

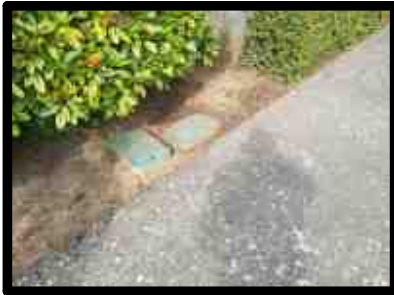
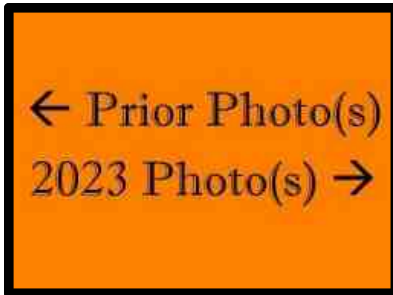
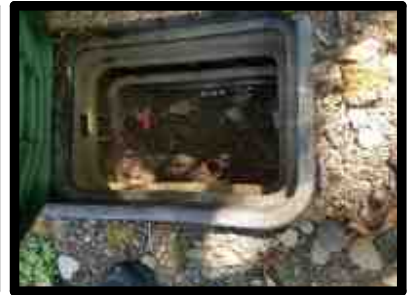
Backflow Device: Common Area - Replacement

We have revised this base price due to inflation since the 2024 reserve study and one year has been subtracted from the useful remaining life of this line item.

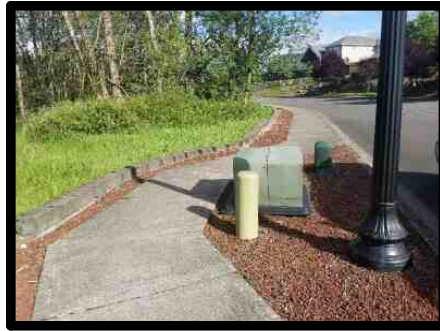
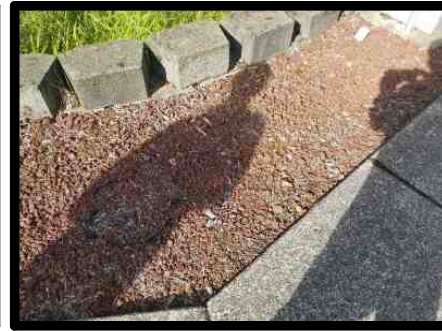
Lava Rock: Replenish

We have revised this base price due to inflation since the 2024 reserve study and one year has been subtracted from the useful remaining life of this line item.

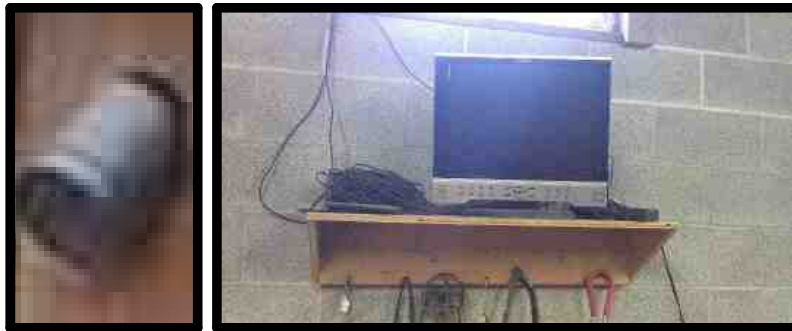
Surveillance Equipment

We have revised this base price due to inflation since the 2024 reserve study and one year has been subtracted from the useful remaining life of this line item.

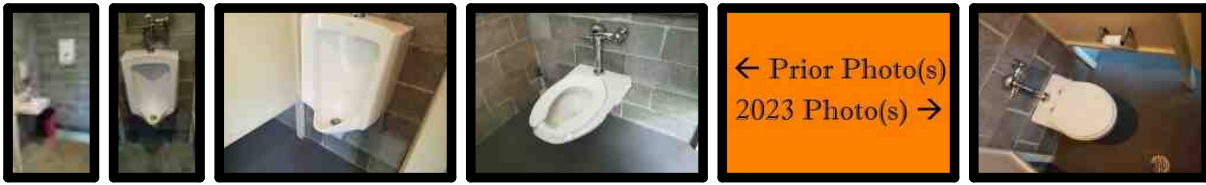
Restroom Refurbishment - Provision

We have revised this base price due to inflation since the 2024 reserve study and one year has been subtracted from the useful remaining life of this line item. The Homeowners Association is strongly encouraged to affirm this cost with a competitive bid/estimate.

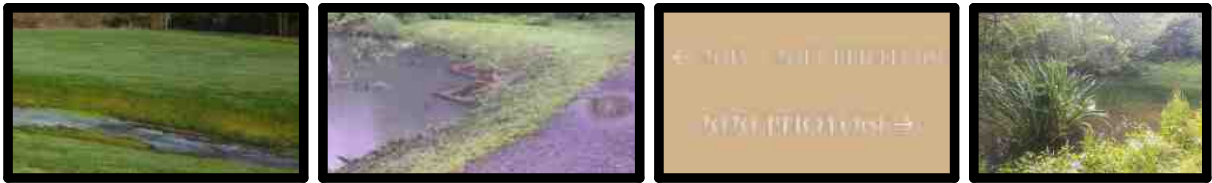
Water Quality Discharge Pond - Biofilter [Phase 2A]

Per the BOD the remainder of the Biofilter project is now anticipated in two phases, occurring in 2025 and 2026, with regular maintenance occurring every two years starting in 2028.
