Lacamas Shores
Homeowners' Association
Camas, Washington

LACAMAS SHORES HOA MEADOWLANDS PARK WETLAND DELINEATION & PROPOSED VEGETATION PLAN

TO: Donald Trost, President, Lacamas Shores Homeowners' Association
FROM: Jennifer Wynkoop
DATE: February 3, 2023
RE: **Wetland Evaluation**
Lacamas Shores Community
Camas, Washington
Landau Project No. 2015001.020

LACAMAS SHORES MITIGATION PLAN SET

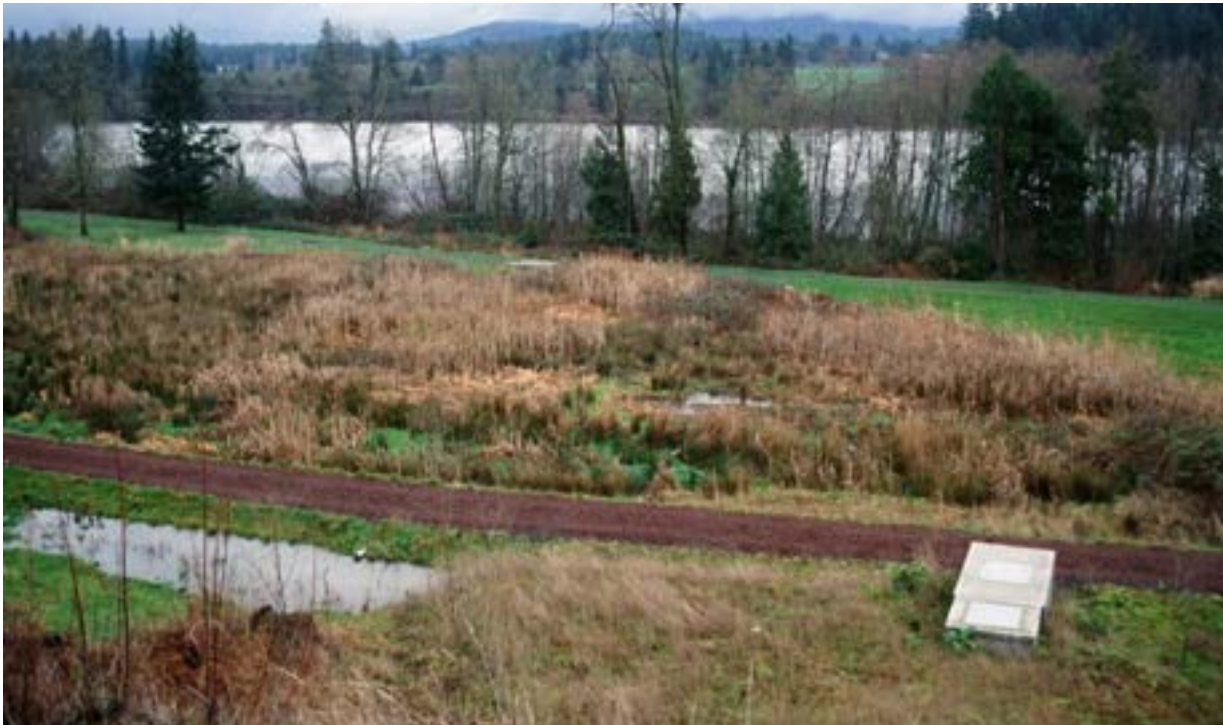
Photo 1. Storm Water Vault "B1" and wetland as it appeared in 1992. Looking NE from behind home at 2437 NW Lacamas Drive. Stan Geiger photo 2/21/1992

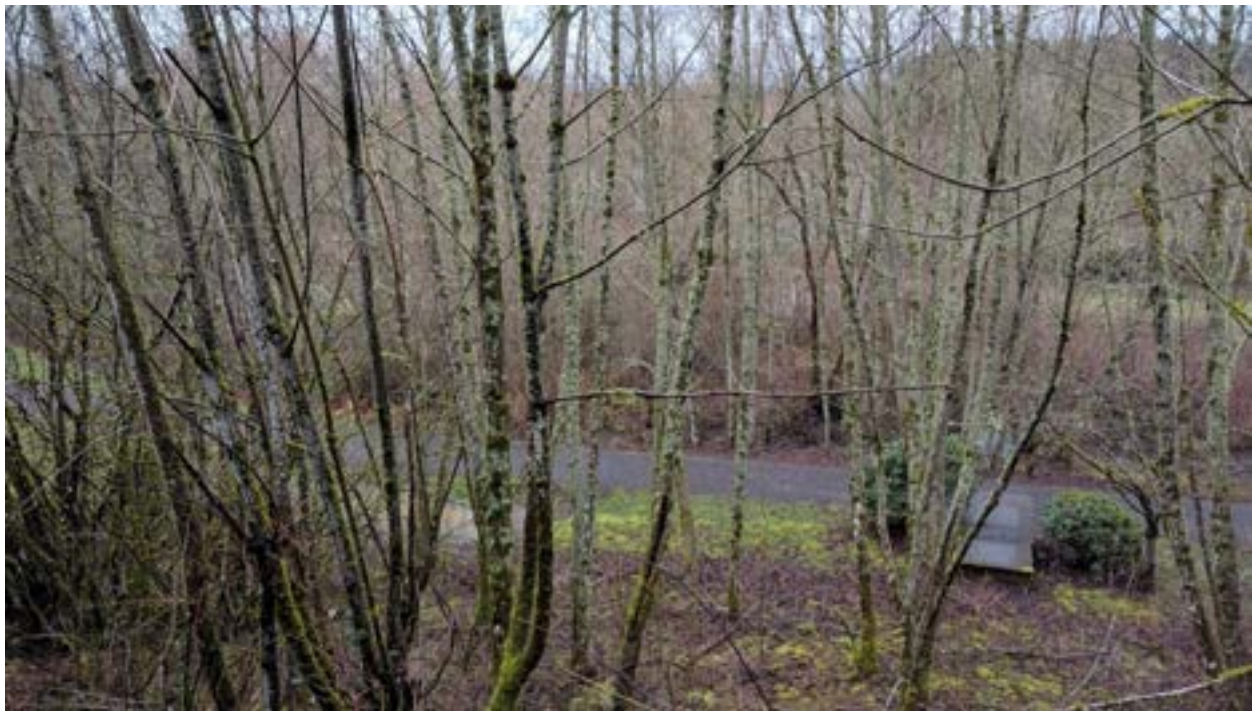
Photo 2. Same view as photo 1 taken 25 years later. ETC photo 2/20/2017.

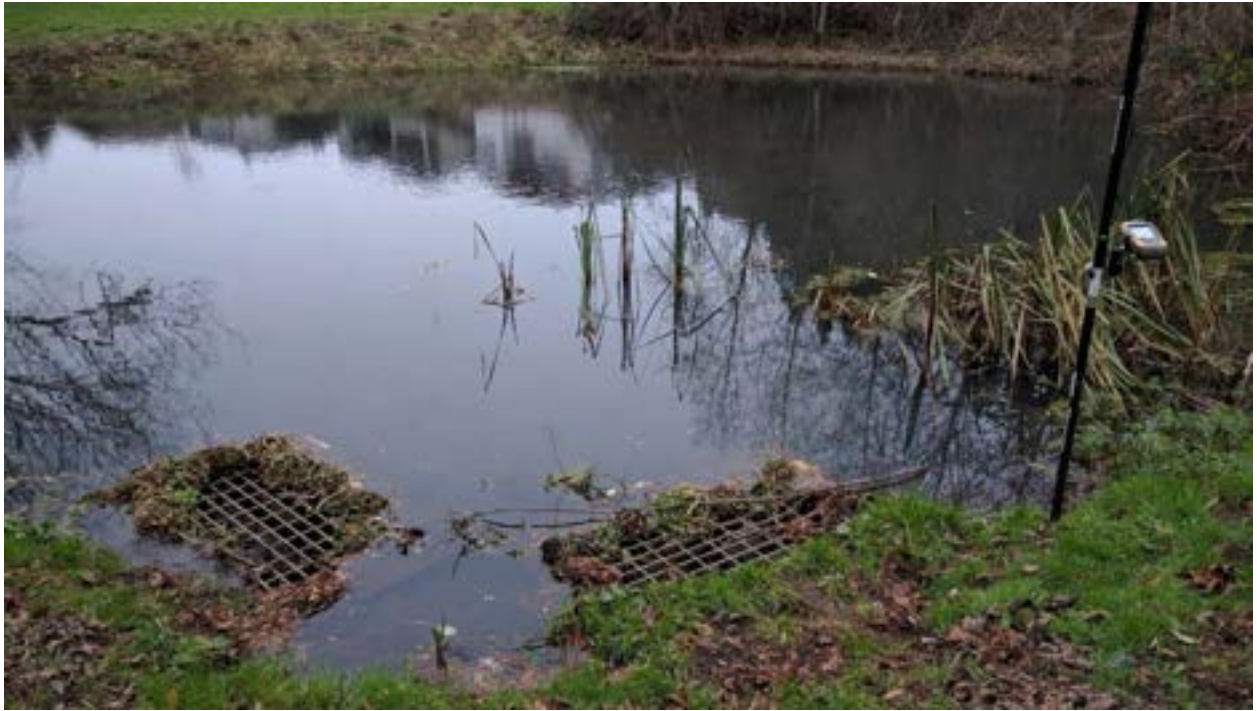
Photo 3. Settling pond and drains built as part of the 1996 Stormwater modification.

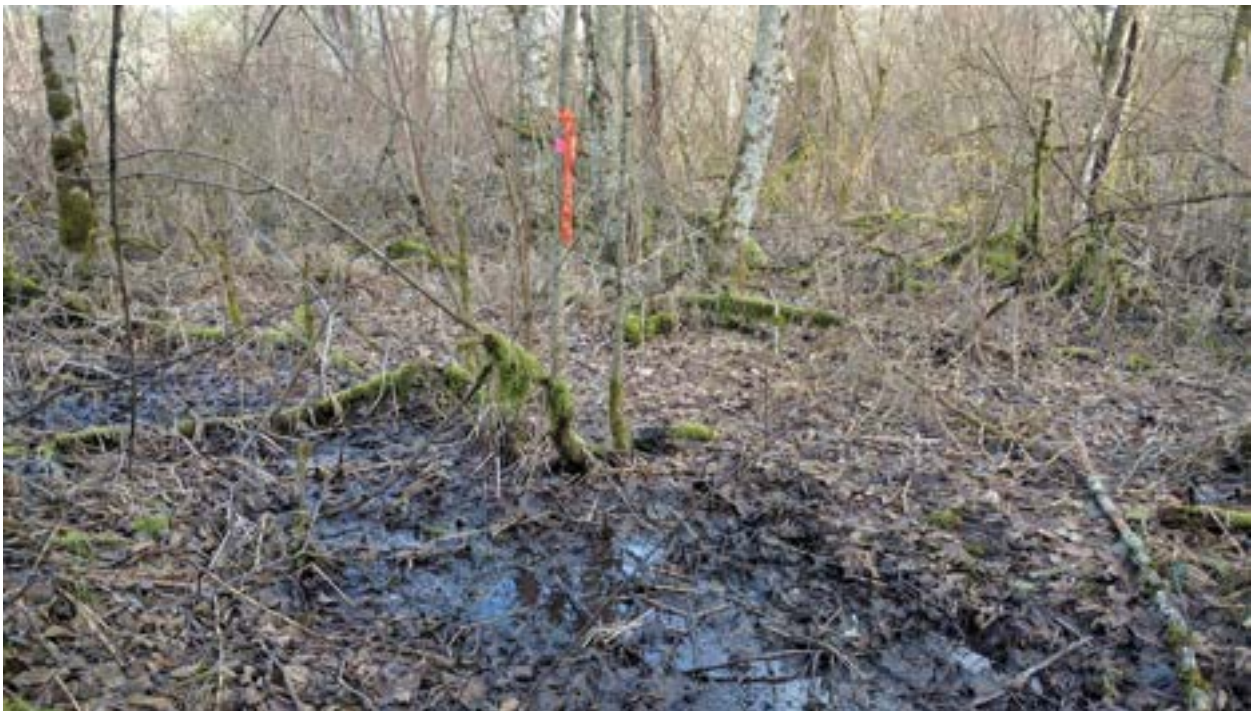
Photo 4. Data plot P1. This is in the upper portion of the wetland areas created by the stormwater filtration facility. ETC photo 2017

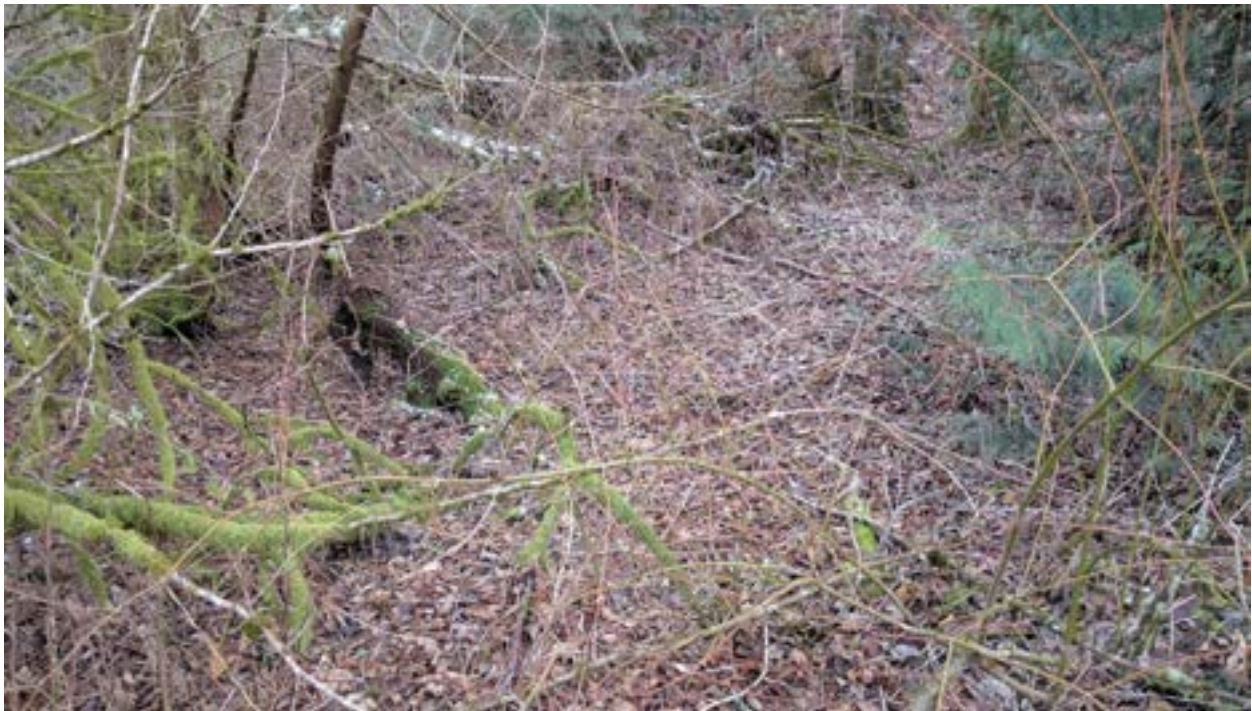
Photo 5. Wetland "B", a small forested wetland, mostly seasonally saturated soils. Wetland "B" historically was part of a large wetland in the shoreline of Lacamas Lake, though became isolated through construction of the boat ramp and picnic facilities. ETC photo 2017

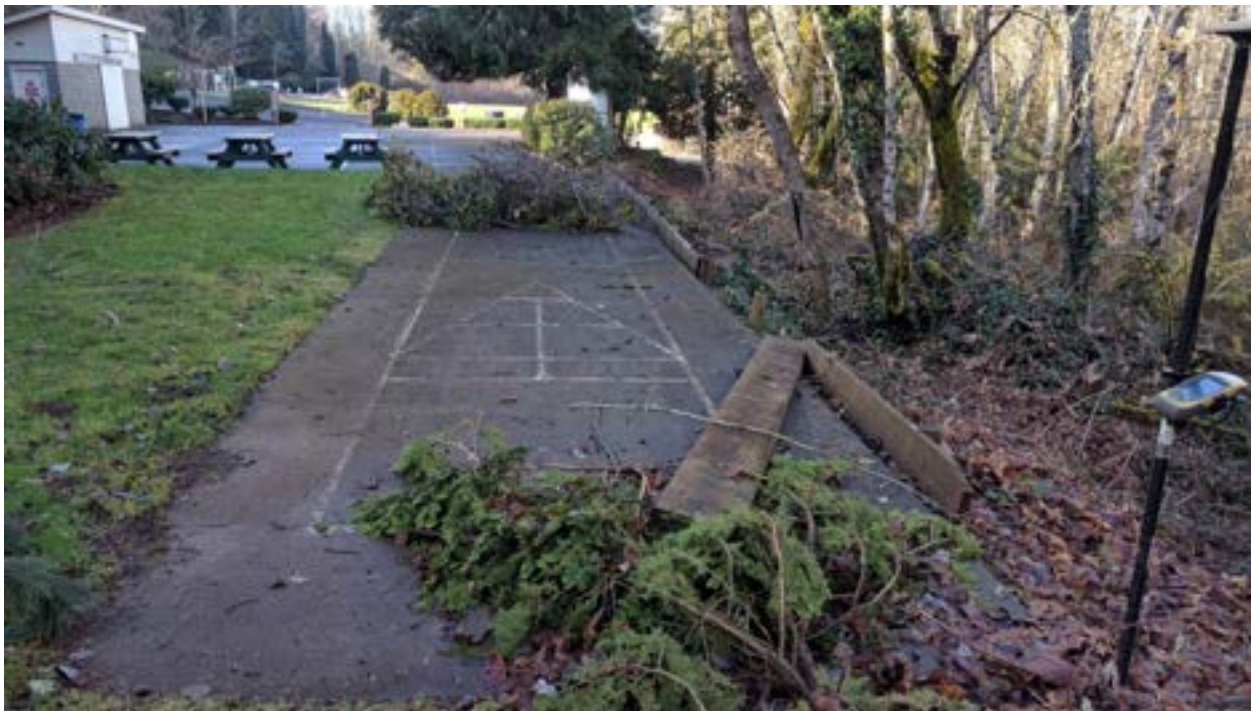
Photo 6. Picnic area. Part of the development that functionally isolates Wetland "B" from portions of it's 165ft buffer. ETC photo 2017

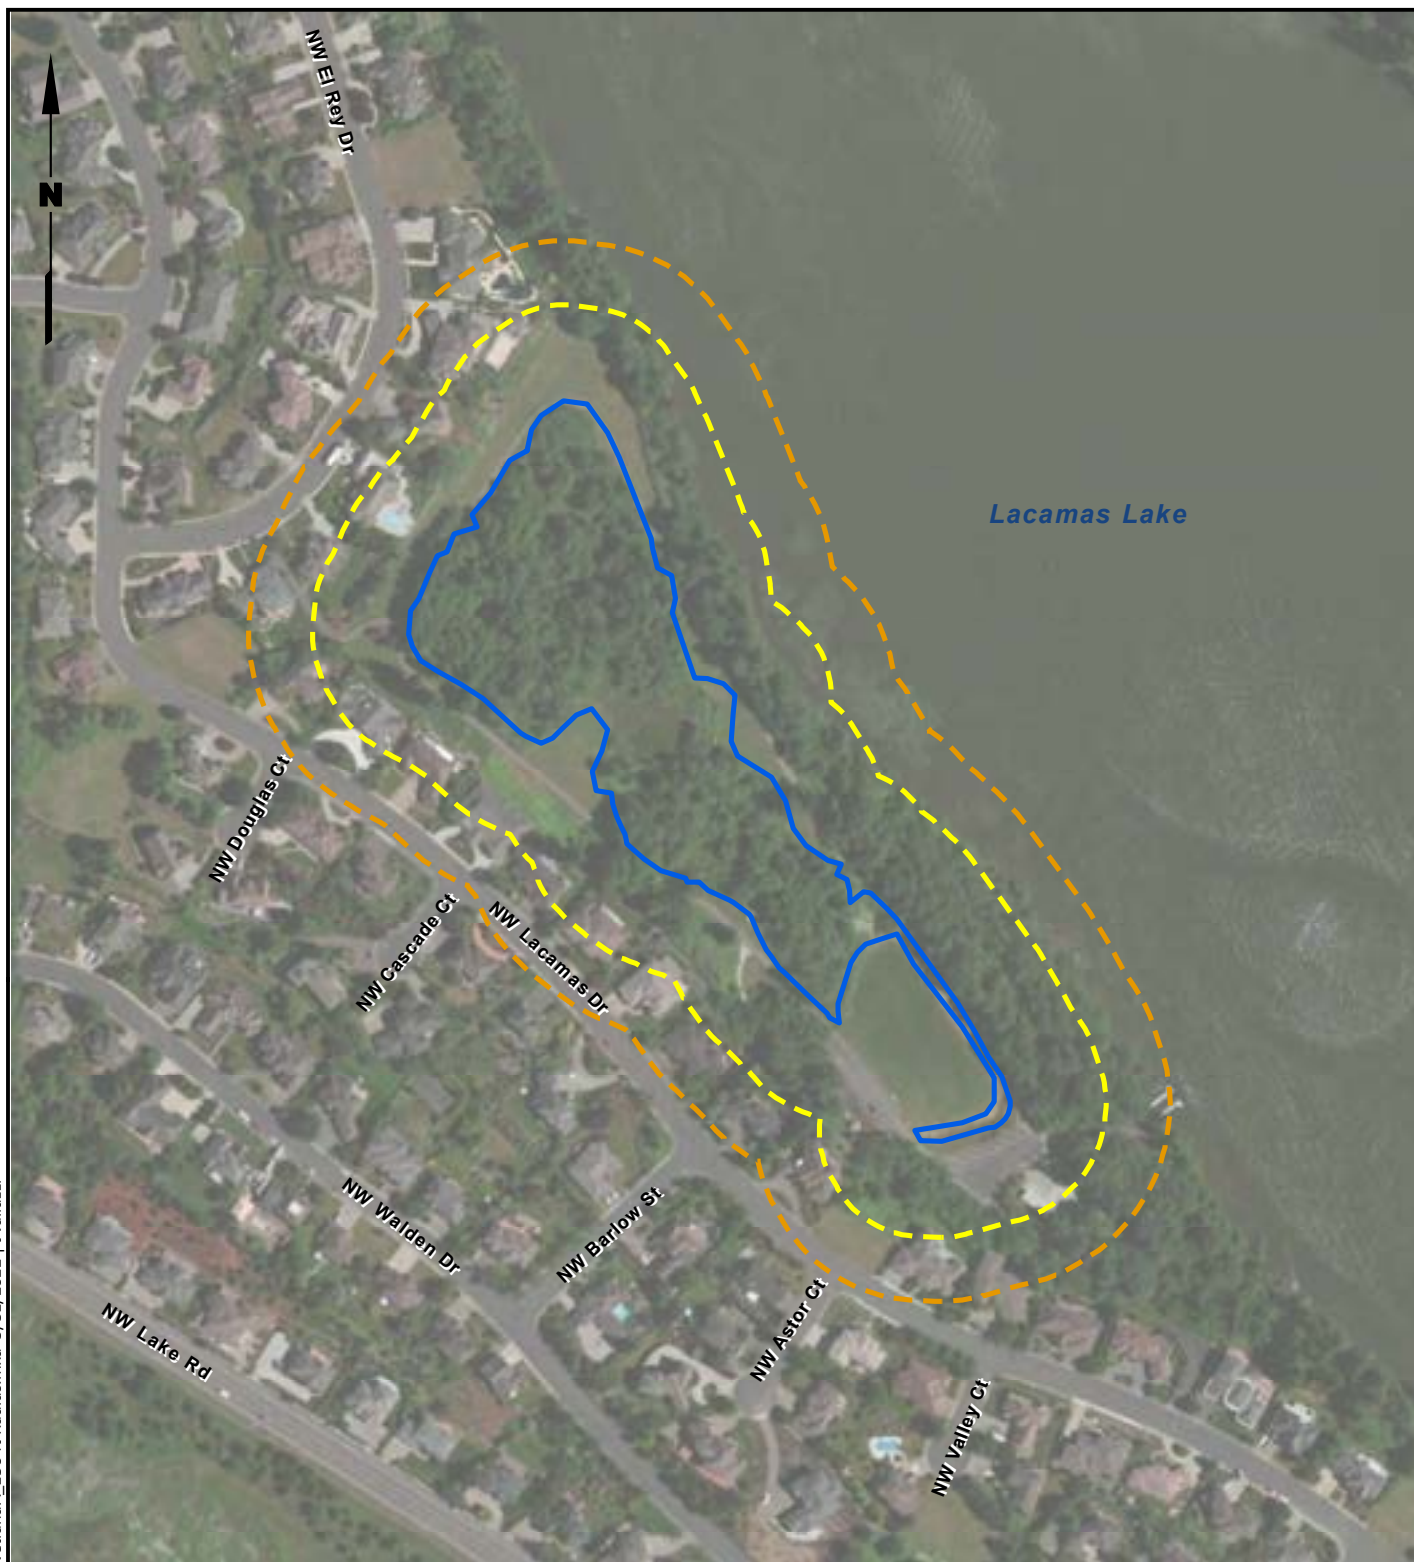
Lacamas Shores Homeowners Association Camas Washington	Hydroperiods	Figure 2-3
--	--------------	---------------

A range of hydrologic regimes (hydroperiods, presence of water) were observed within the wetland at the time of the site visit. Some areas were saturated to the ground surface but without standing water (saturated); some areas contained standing water (1 to 6 inches); the two channels contained flowing water; and two areas of ponded water were identified (the southeastern stormwater pond and an area in the northeast corner of the wetland. The settling pond was approximately 1.5 feet deep in the area near its outlet; the depth of the center of the pond could not be estimated at the time of the site visit, but appeared to be deeper than 14 inches. Ponding depth in the northeastern corner of the wetland also could not be estimated at the time of the site visit due to dense brush and trees, but the ponded area appeared to have no outlet. Figure 2-3 in Attachment 2 shows the various hydrologic regimes within the wetland.

Heavy rain fell on and off at the time of the site visit, and several small water courses were observed through the wetland, trending in a generally west-to-east direction and flowing toward Lacamas Lake. The more northern of the two courses contained the most flow and a portion of the flow appeared to be from the northwest bubbler (bubbler No. 2, Figure 2-3). The northern water course flows out to Lacamas Lake via a culvert outflow on the east side of Wetland A (northern outlet). A smaller water course exits Wetland A via a culvert to the south (southern outlet); the water course at the southern outlet had minimal flow and did not appear to transect the wetland. The source of the flow could not be discerned during the site visit due to dense brush, but it was not connected to the water courses bisecting Wetland A. A settling pond was observed on the wetland's southeastern side. The water level in the pond was relatively high at the time of the site visit, and water was discharging from the pond to the shoreline of Lacamas Lake via a series of culverts. Water entered the pond via a water course from the west side of Wetland A and from a constructed stormwater swale bordering the adjacent athletic field. The water course from the west formed just downgradient of the bubbler. A portion of the stormwater from bubbler No. 1 was also discharging from around the bubbler manhole and ponding in a small area. Water also discharges from the wetland to Lacamas Lake via a southern outlet that is separate from the pond outlet.

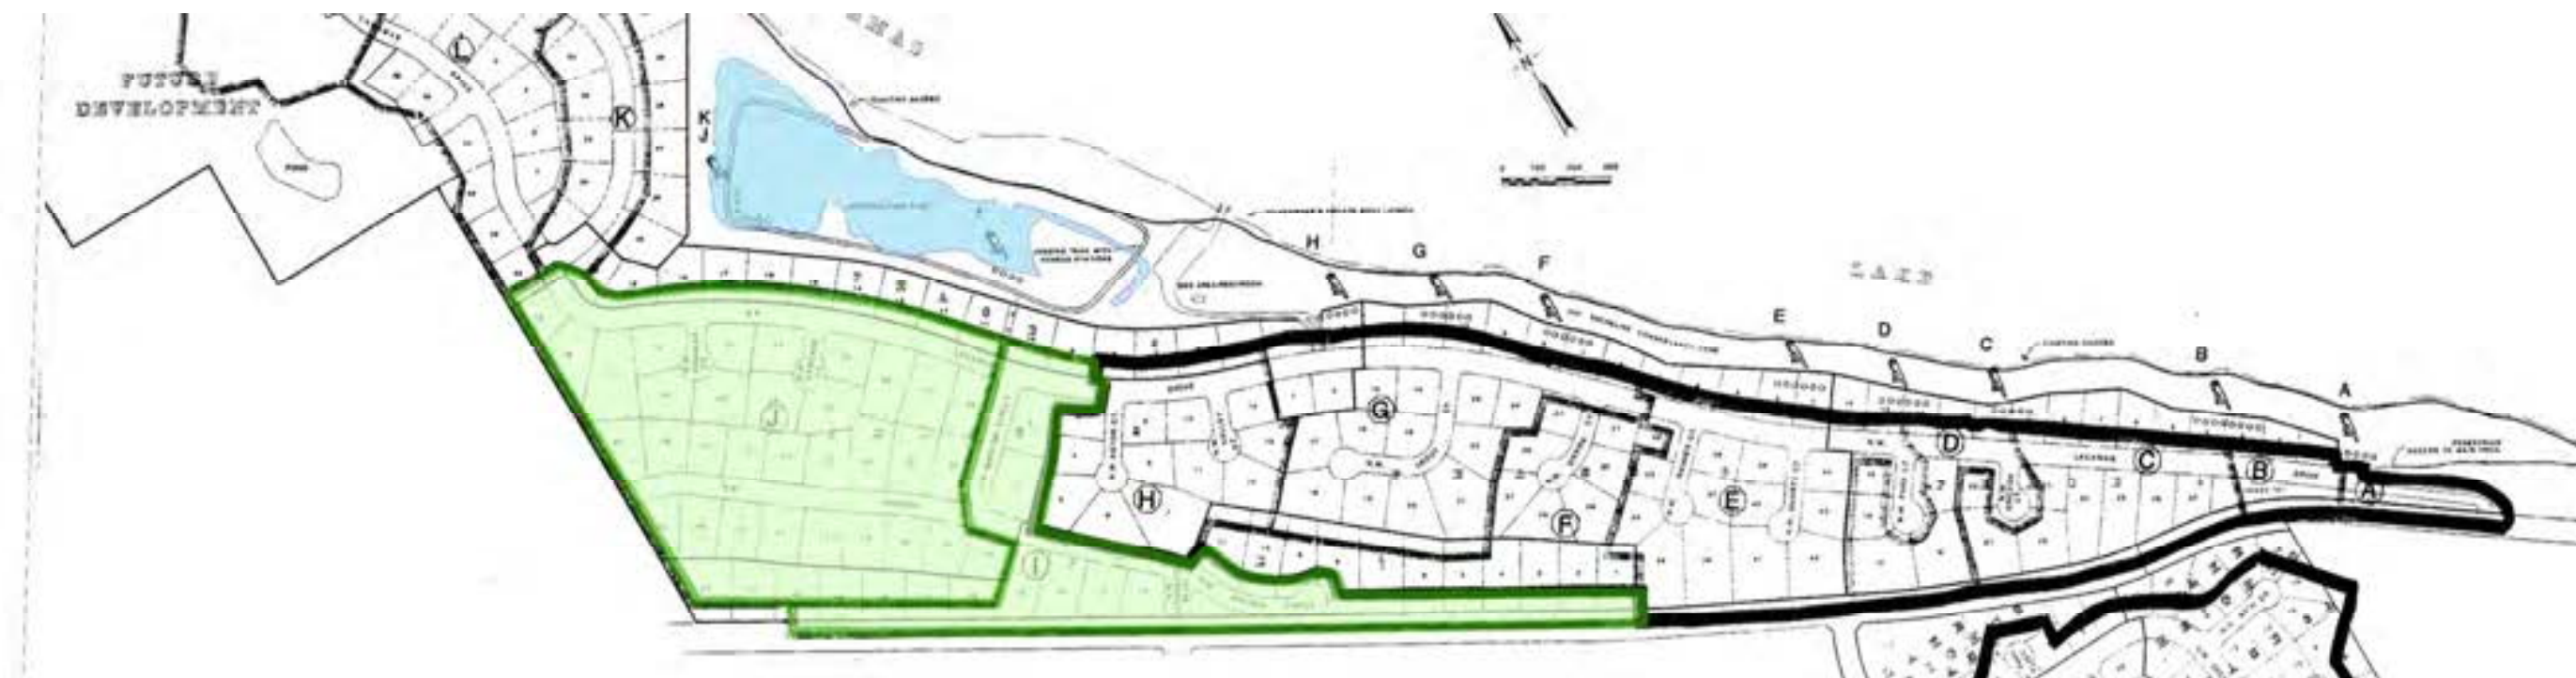
DRAINAGE BASIN	AREA
A	1.2 Ac.
B	1.2 Ac.
C	5.8 Ac.
D	3.8 Ac.
E	9.3 Ac.
F	1.2 Ac.

- Notes**
- Basins I and J drain to wetland, as well as approximately 3 acres of additional hill-slope and back yard areas. In total, the drainage basin is approximately 35 acres.
 - Black and white reproduction of this color original may reduce its effectiveness and lead to incorrect interpretation.
